NIST Response to the World Trade Center Disaster

Federal Building and Fire Safety Investigation of the World Trade Center Disaster

Media and Public Briefing April 5, 2005

Dr. S. Shyam Sunder Acting Deputy Director and Lead Investigator Building and Fire Research Laboratory National Institute of Standards and Technology U.S. Department of Commerce

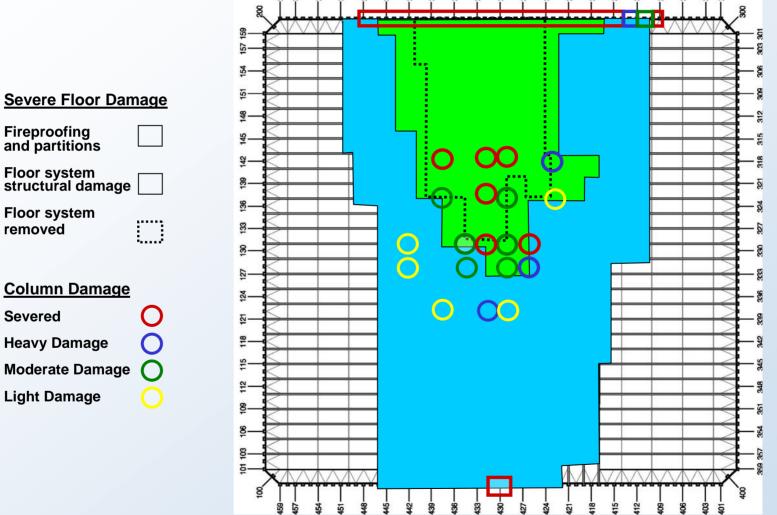
WTC 1 Damage: Composite Summary for Floors 93 to 98

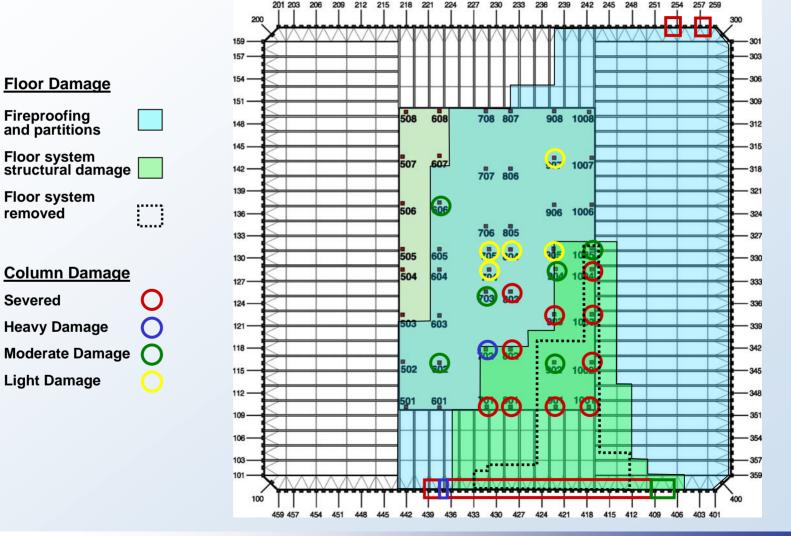
WTC 2 Damage: Composite Summary for Floors 78 to 83

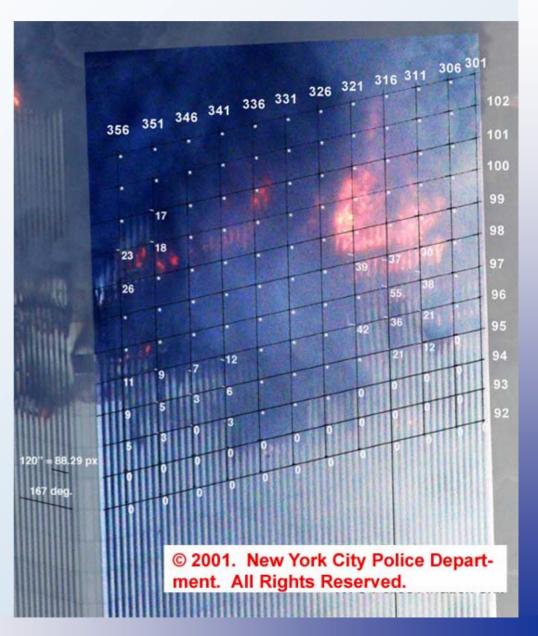
Inward Bowing of Perimeter Columns About 2 Minutes Prior to Collapse: WTC 2 East Face

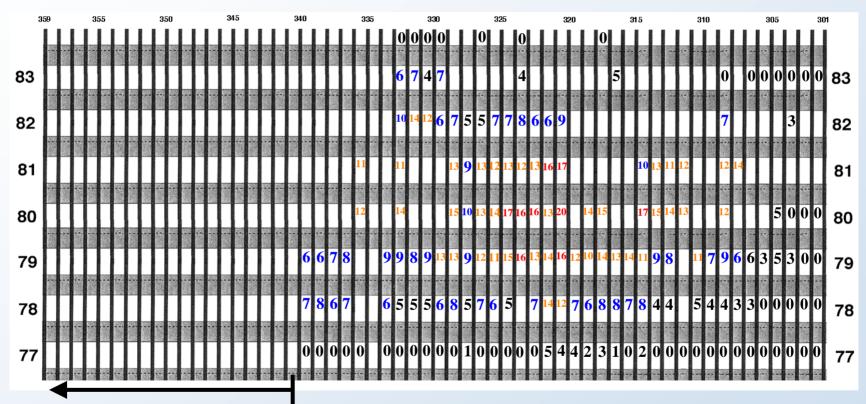
Map of Inward Bowing: East Face of WTC 2 Time: 9:52:54 AM to 9:53:04 AM

Empty regions have no data (smoke, damaged aluminum, could not establish true vertical, etc.)

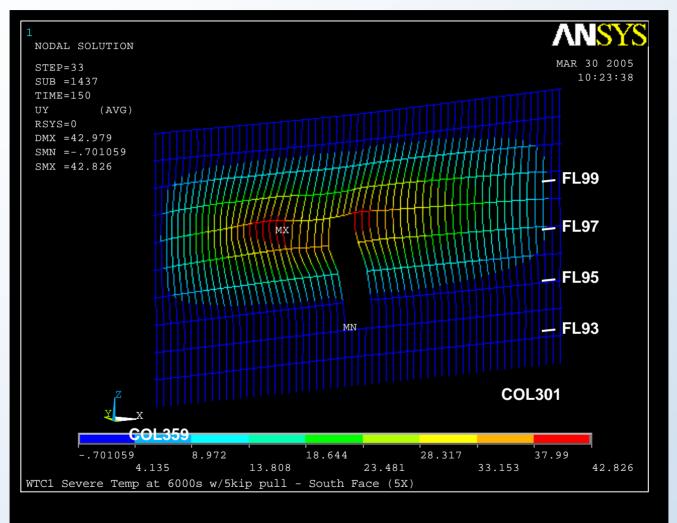
Inward Bowing of the WTC 1 South Face at 6000 s

Maximum Inward Displacement = 43 in. Looking from the outside of the building Inward displacement is shown as positive displacement

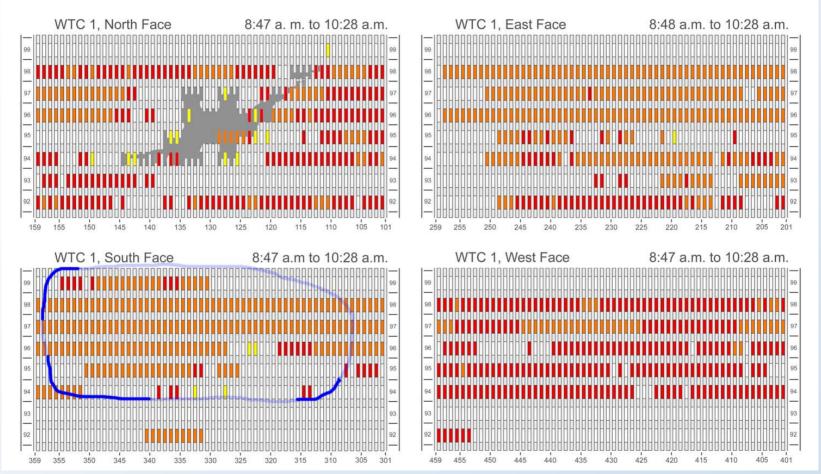
Visual Evidence of Fires in WTC 1

Dark blue line indicates extent of inward bowing observed in visual images. Light blue line is estimated region of inward bowing where visual images were obscured.

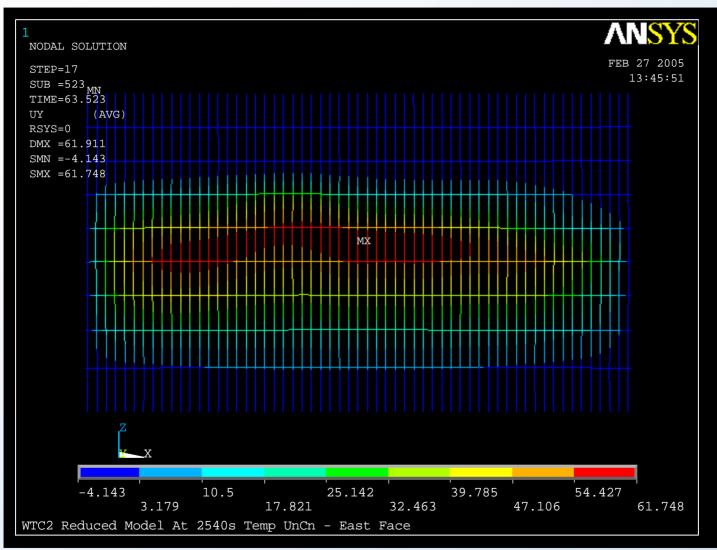
Inward Bowing of the WTC 2 East Face at 2,540 s

Maximum inward displacement = 60 in.

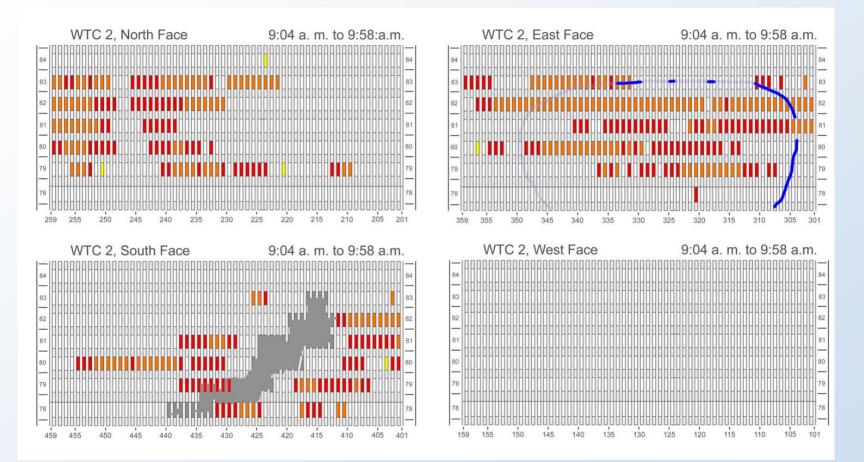
Visual Evidence of Fires in WTC 2

Dark blue line indicates extent of inward bowing observed in visual images. Light blue line is estimated region of inward bowing where visual images were obscured.

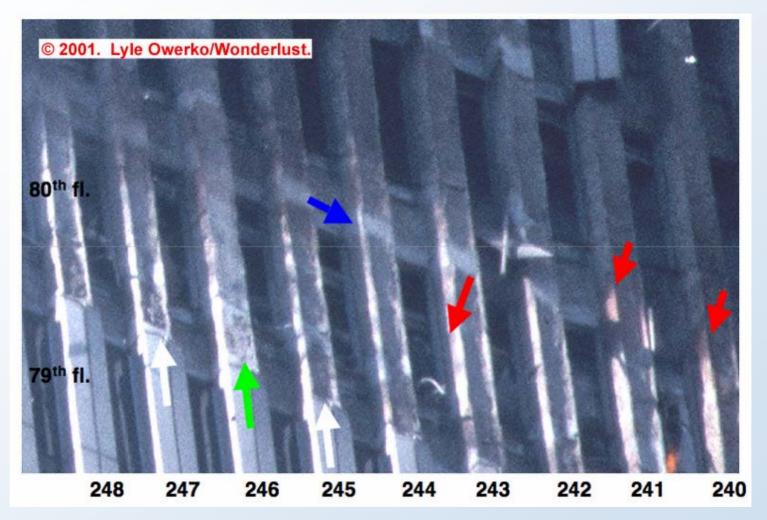
Damaged SFRM - North Face of WTC 2

Removed from flanges (red)

Intact (green)

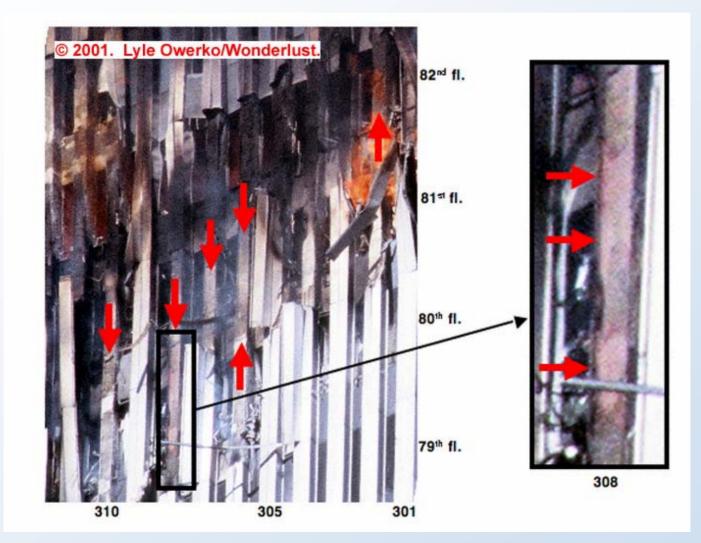
Damaged SFRM - East Face of WTC2

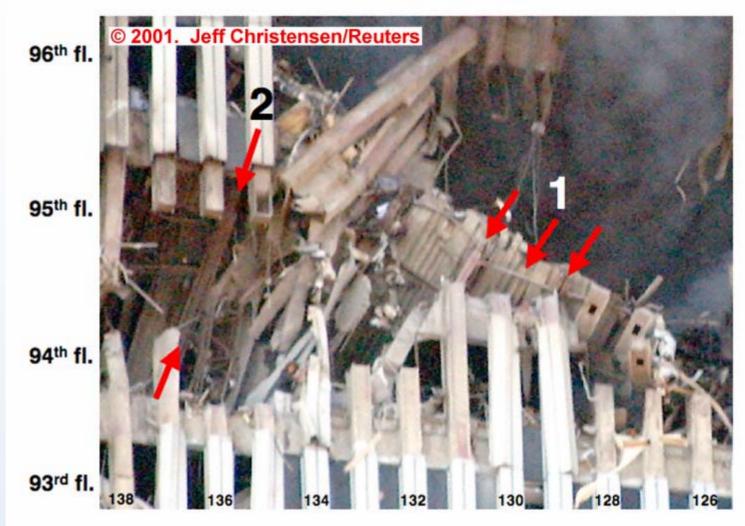
Damaged SFRM - North Face of WTC 1: Missing from Trusses

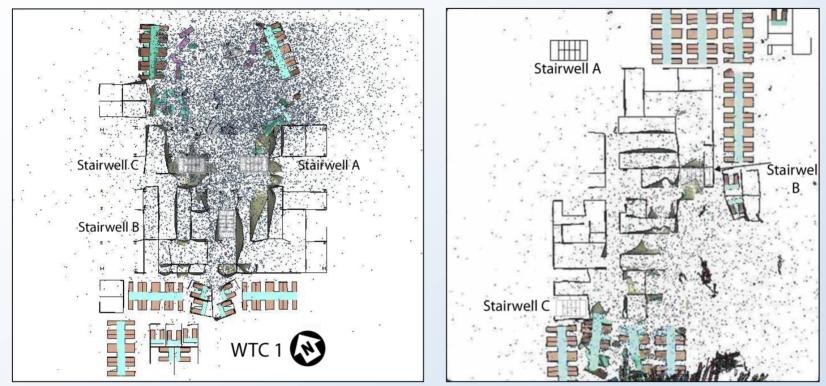
Condition of Stairwells

- The stairwells, with partition wall enclosures that provided a 2 h fire-rating but little structural integrity, were damaged in the region of the aircraft impacted floors.
- One of the stairwells in WTC 2 (Stairwell A on the Northwest side) was passable in the region of aircraft impact for some period of time after WTC 2 was attacked.
- All three stairwells in WTC 1 and the two other stairwells in WTC 2 were rendered impassable in the region of aircraft impact.

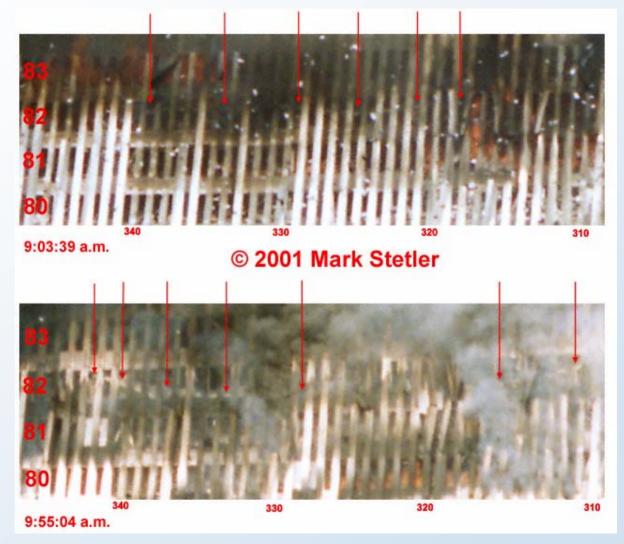
Photographic Evidence of Hanging Floor Slab

Amount and extent of floor sag increased over the 51 minute period.

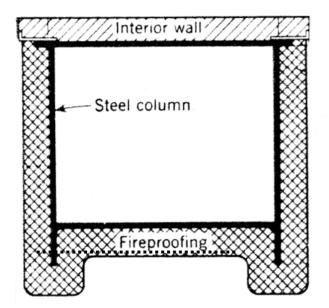
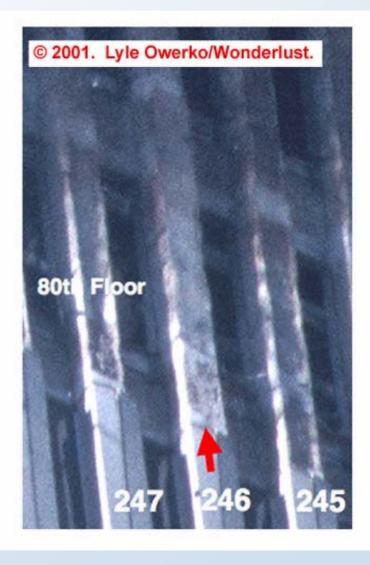
Application of SFRM to External Columns

- By design, uniform thickness
- As applied, region between flange tips filled (for example, see column 246 at right)
- Missing SFRM from outer flange indicated by shadowing and exposed red paint

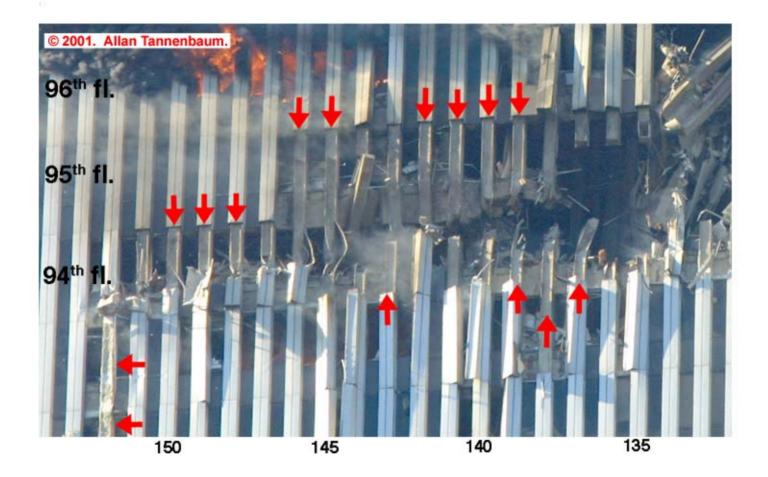
Damaged SFRM - North Face of WTC 1: Left Side of Impact Hole
