***Direct Visual Signaling as a Means for  
Occupant Notification in Large Spaces  
Research Project***

*Technical report*

# **Direct Visual Signaling as a Means for Occupant Notification in Large Spaces**

**An Engineering Study Sponsored by  
the Fire Protection Research Foundation**

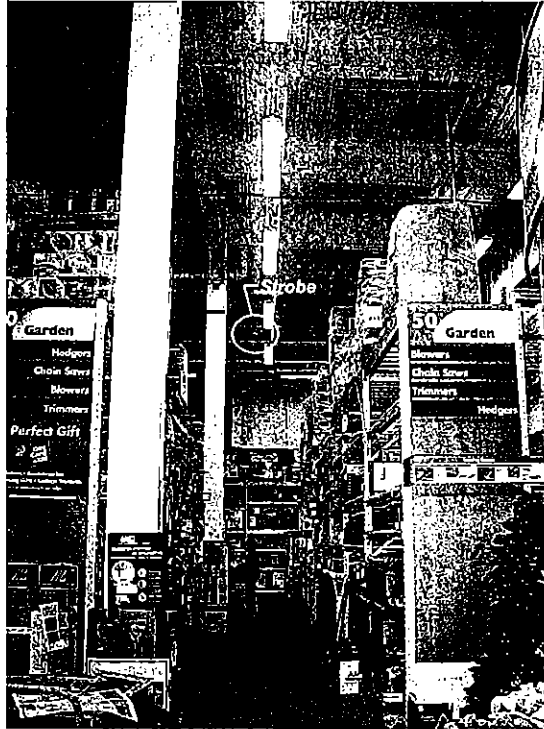
Photo 1 - Strobe Over Aisle (Reading, MA)

Photo 1 shows a picture of a typical rack aisle with a strobe located directly overhead. A close-up of the strobe in Photo 2 shows the ceiling configuration and the location of the strobe relative to the building lights and structural steel.

The strobes at this location are located below the ceiling, at about the same level of the hanging fluorescent lights. The original design called for the strobes to be located over the aisles, between racks. Within each aisle, the strobes are spaced approximately 45 to 48 ft. Rack spacing varies with most 16 ft on center and some as much as 30 ft on center. Thus, strobe coverage might be 45 ft x 16 ft in order to provide a line of strobes in each rack aisle. However, after the system was installed, the rack layout was altered resulting in many lines of strobes not falling directly over an aisle.
