***Direct Visual Signaling as a Means for
Occupant Notification in Large Spaces
Research Project***

Technical report

**An Engineering Study Sponsored by
the Fire Protection Research Foundation**

**Report Issued:
12 January 2006**

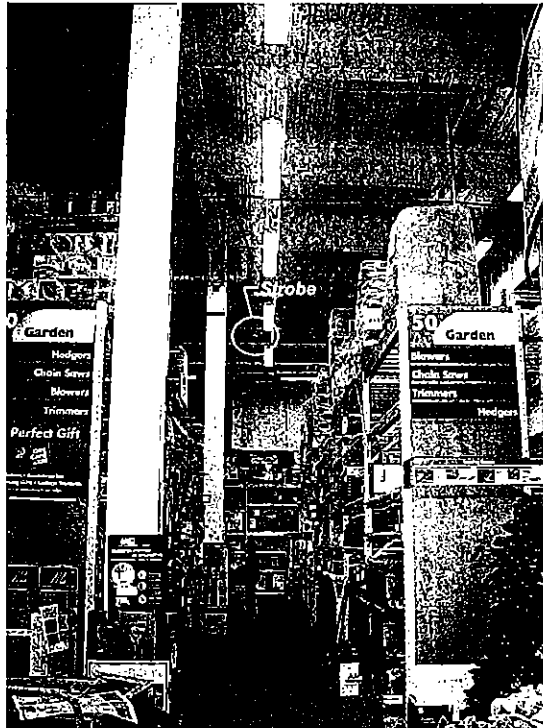
Photo 1 shows a picture of a typical rack aisle with a strobe located directly overhead. A close-up of the strobe in Photo 2 shows the ceiling configuration and the location of the strobe relative to the building lights and structural steel.

Photo 1 - Strobe Over Aisle (Reading, MA)

The strobes at this location are located below the ceiling, at about the same level of the hanging fluorescent lights. The original design called for the strobes to be located over the aisles, between racks. Within each aisle, the strobes are spaced approximately 45 to 48 ft. Rack spacing varies with most 16 ft on center and some as much as 30 ft on center. Thus, strobe coverage might be 45 ft x 16 ft in order to provide a line of strobes in each rack aisle. However, after the system was installed, the rack layout was altered resulting in many lines of strobes not falling directly over an aisle.

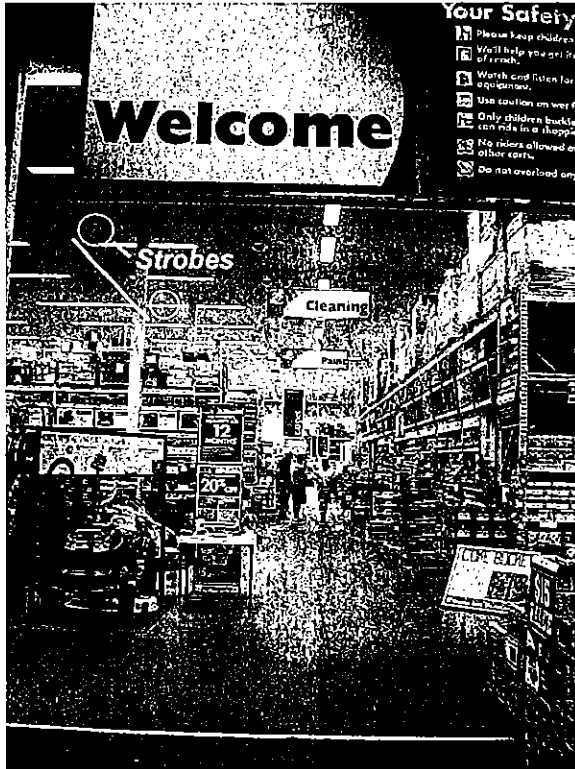
Photo 3 shows lines of strobes on the ceiling. Photo 4 shows an aisle with strobes directly overhead. Photo 5 is a close-up of a strobe on the suspended ceiling.

Photo 3 - Lines of Strobes

The strobes at this location are located on a suspended acoustical tile ceiling at the same level of the building's fluorescent lights. The design and installation resulted in most strobes being located over the aisles, between racks. Within each aisle, the strobes are spaced approximately 48 ft. Rack spacing varies with most 16 ft on center and some as much as 30 ft on center. Thus, strobe coverage might be as low as 48 ft x 16 ft in order to provide a line of strobes in each rack aisle.

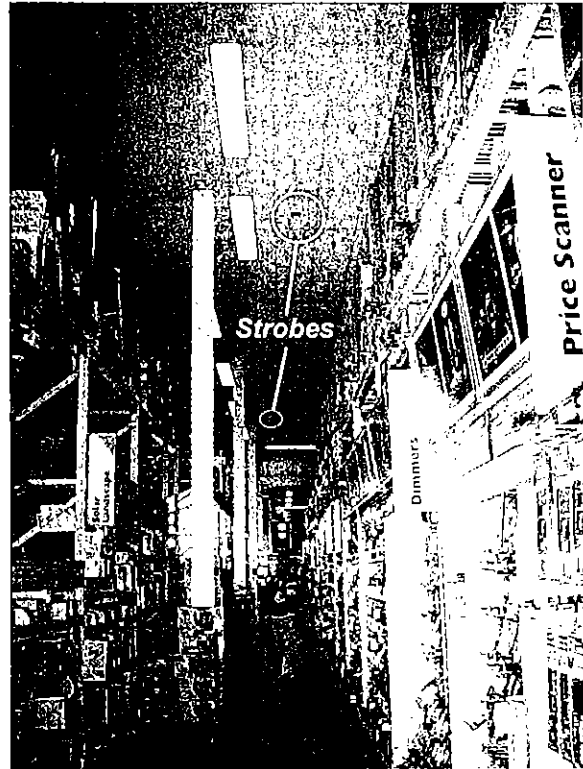
Photo 4 - Strobes Over Aisle

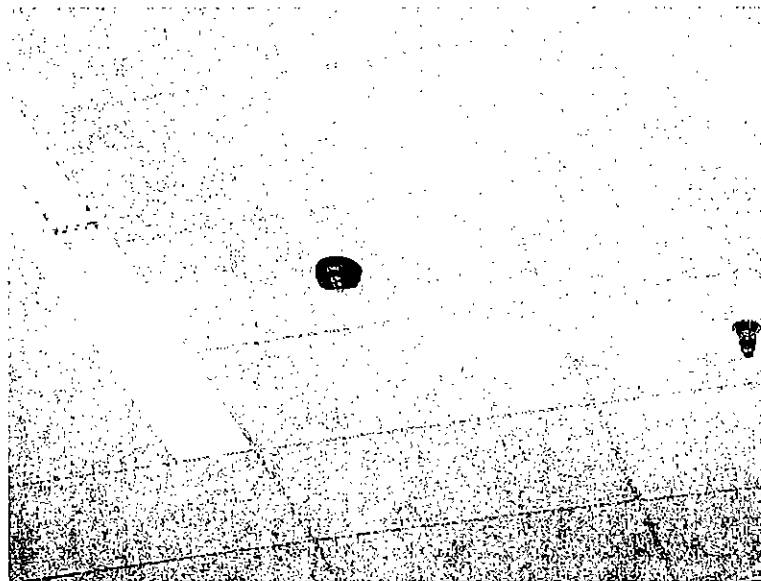
Photo 5 - Close-up of Strobe (Danvers, MA)

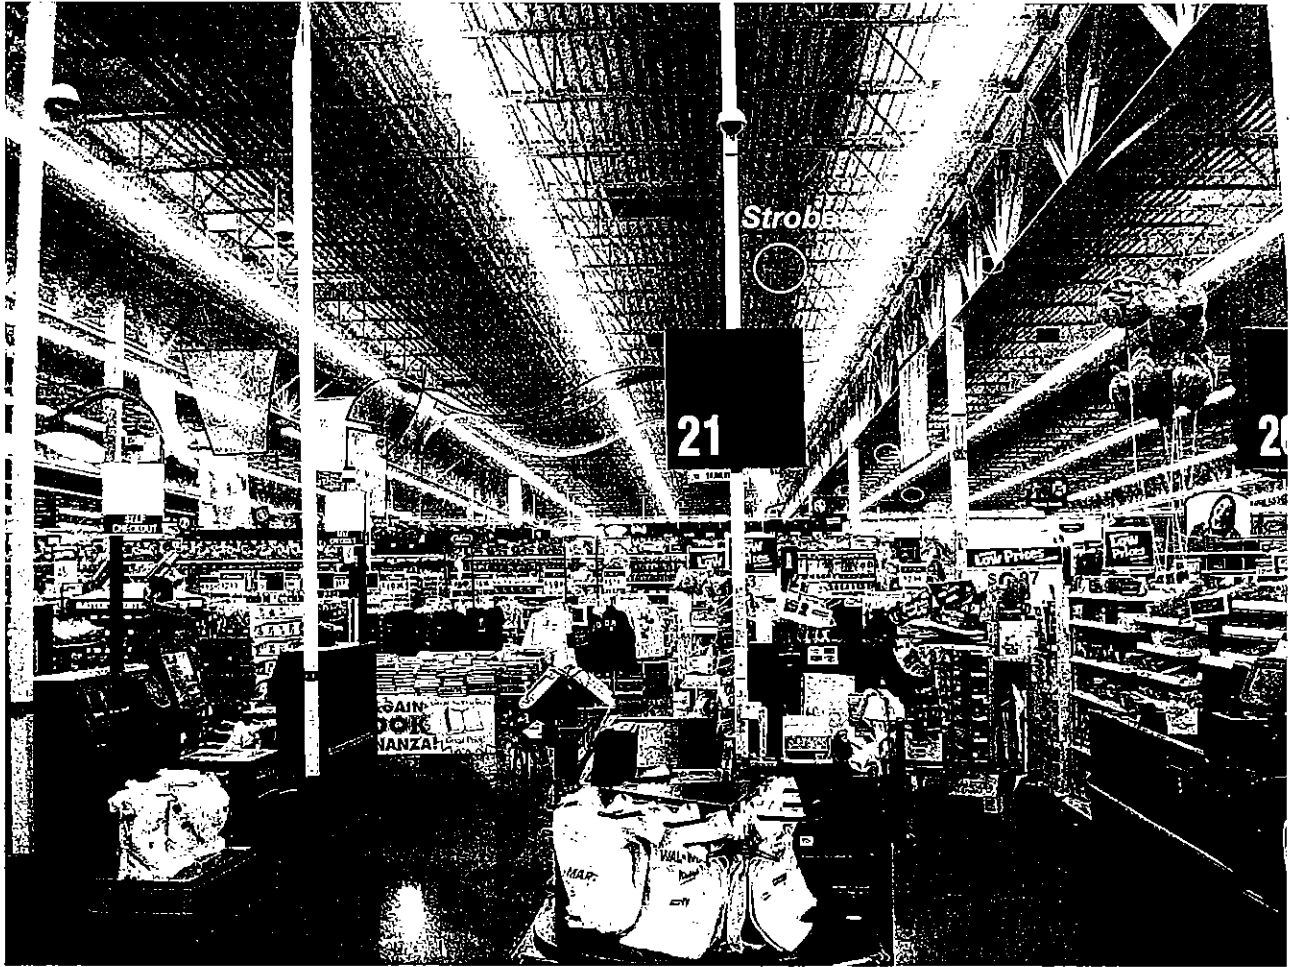
Photo 6 shows the ceiling configuration with strobe lights located on the bottoms of the bar joists.

Photo 6 - Strobes Located on Bottoms of Bar Joists (Kissimmee, FL)

The strobes at this location are located on the bottom of the bar joists supporting the ceiling/roof. The florescent light fixtures are approximately 8 - 12 in. below the bar joists. The design and installation resulted in strobes being located over most of the main aisle and circulation areas. However, not every merchandise aisle has a row of strobes overhead. Typically, the strobes are over the main aisles and over every third to fifth stock aisle.

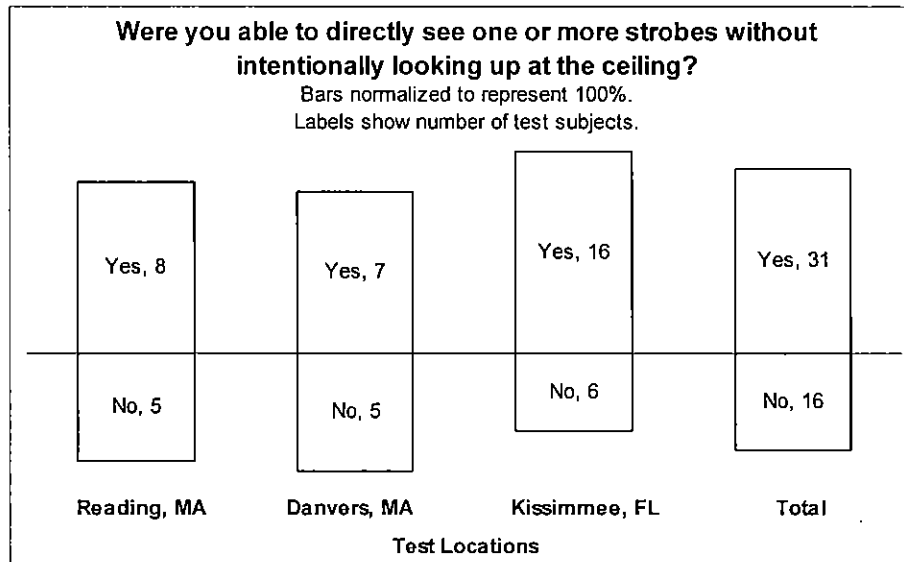
Participants were asked if they were able to actually see (directly view) one or more strobe lights flashing without intentionally looking up at the ceiling. The results, summarized in Figure 5, show that the Kissimmee system was the most effective at direct signaling to occupants.

Figure 5 - Direct Signaling Effectiveness

The better outcome in the Kissimmee Wal*Mart is probably the result of a greater clearance between the top of stock/storage and the strobe lights than either of the two Home depot stores. As a result, occupants could see more of the ceiling and, hence, more strobes from most vantage points. This is discussed in more detail in Section 8. Also, there may still have been locations where strobes or their effects were not viewable – see Blind Spots.

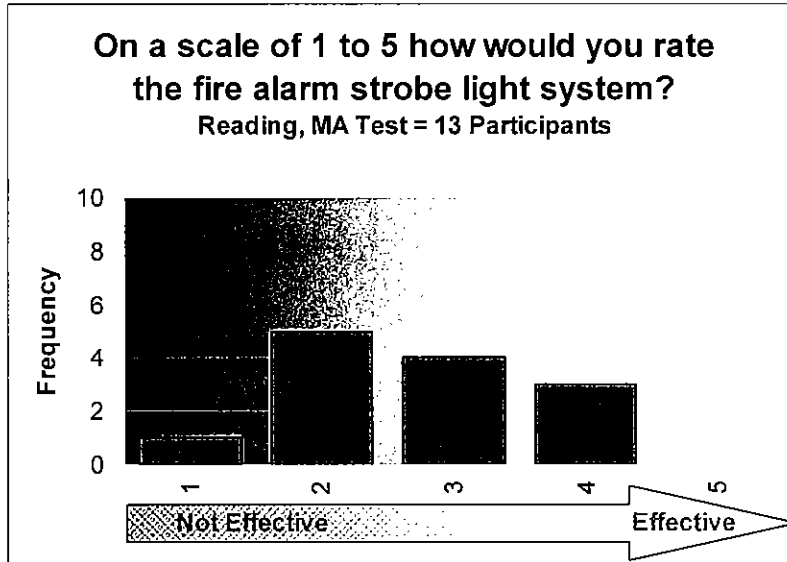
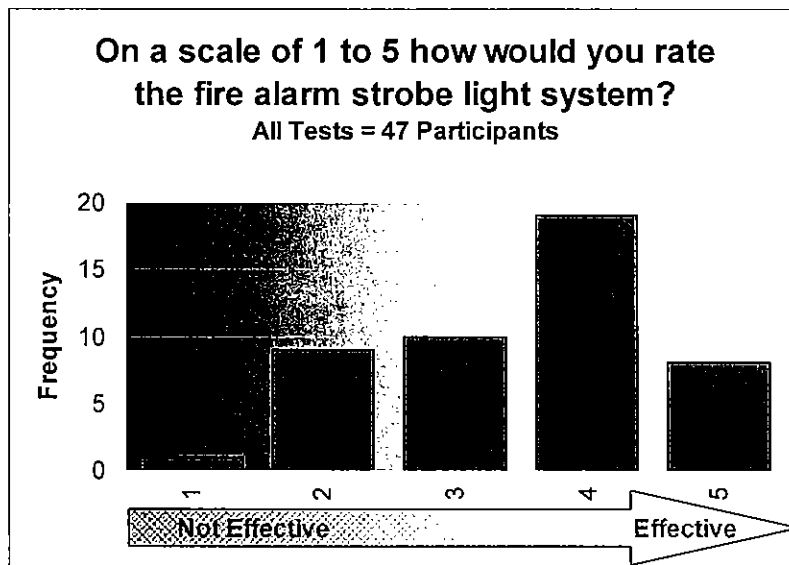
For each location, participants were asked to rate the effectiveness of the fire alarm strobe light system. The results for the three test locations are shown in Figure 11 through Figure 13 and combined for all locations in Figure 14.

Figure 11 - Strobe Effectiveness - Reading

Figure 12 - Strobe Effectiveness - Danvers

Figure 13 - Strobe Effectiveness - Kissimmee

Figure 14 - Strobe Effectiveness - All Locations

In general, the systems were effective. However, clearly there were differences that made the Danvers system stand out as the most effective and the Reading system as the least effective system. The Danvers system used higher intensity strobes, on a reduced spacing and located over almost all aisles between racks. In Reading, the strobes locations were designed to be over aisles. Before completion, the rack layout changed resulting in most aisles not having a row of strobes directly overhead. In Kissimmee, most respondents felt the system was effective. Based on strobe intensity, ceiling height and strobe spacing, the system was over-
