NIST Response to the World Trade Center Disaster

Federal Building and Fire Safety Investigation of the World Trade Center Disaster

Media and Public Briefing April 5, 2005

Dr. S. Shyam Sunder Acting Deputy Director and Lead Investigator Building and Fire Research Laboratory National Institute of Standards and Technology U.S. Department of Commerce

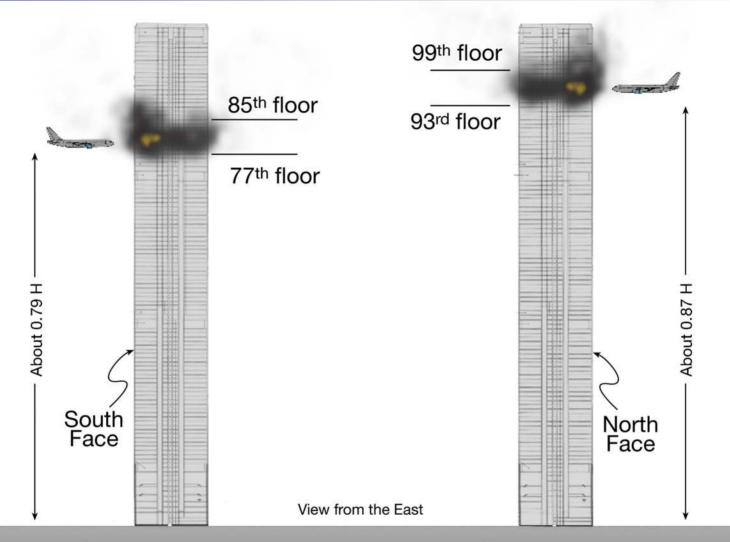
WTC 2: Hit at 9:02:59 a.m. Collapsed after 56 minutes WTC 1: Hit at 8:46:30 a.m. Collapsed after 102 minutes

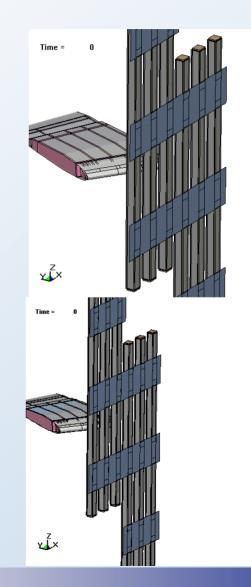
Preliminary Aircraft Impact Damage Analysis

- The impact of the exterior wall by an empty wing segment produces significant damage to the perimeter columns, not necessarily complete failure.
- The impact of a fuel-filled wing section results in extensive damage to the exterior wall panel, including complete failure of the perimeter columns.

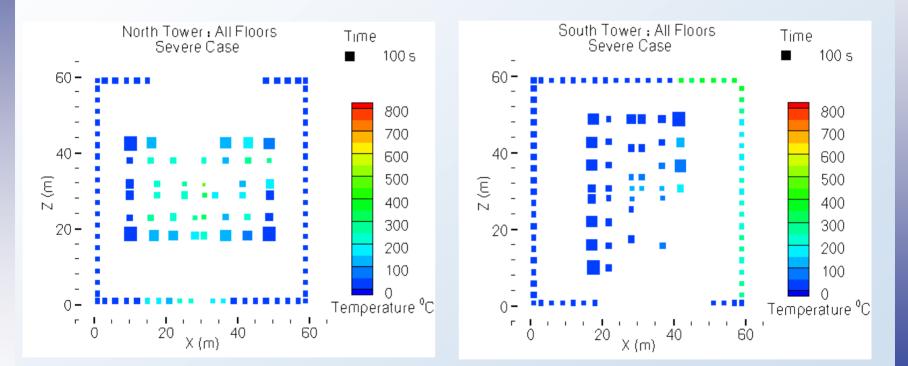
Results of Thermal Analysis

Shows maximum temperature reached by each column.

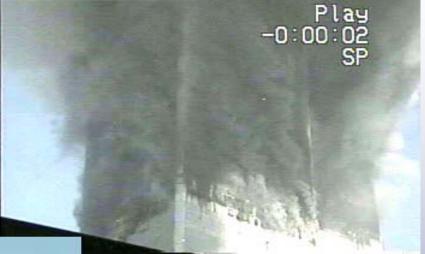
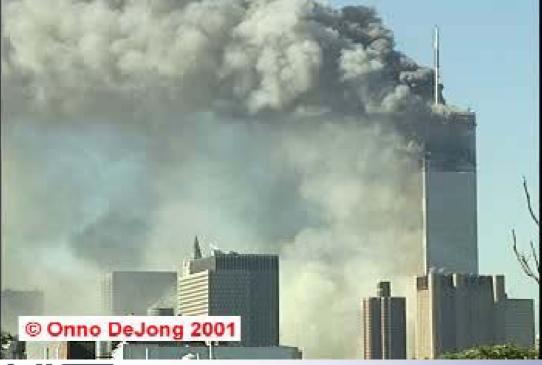
WTC 1 tilted to the south; WTC 2 tilted to the east and south.

Initiation of global collapse was first observed by the tilting of building sections above the impact regions of both WTC towers.
